The Bickford Family Knitting Machine

By Fred Hauck

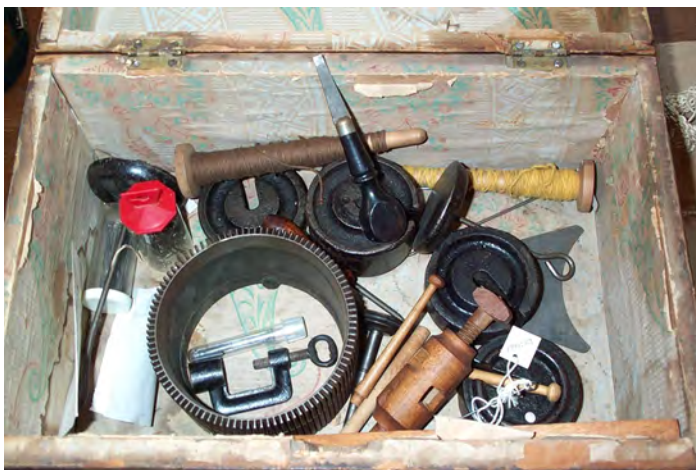
This box is not likely to be an original container. It would not accommodate the machine and all accessories. Note screw driver, cylinder, weights, bobbins and pack of needles (red cap) The clamp inside the cylinder is a swift mounting clamp.

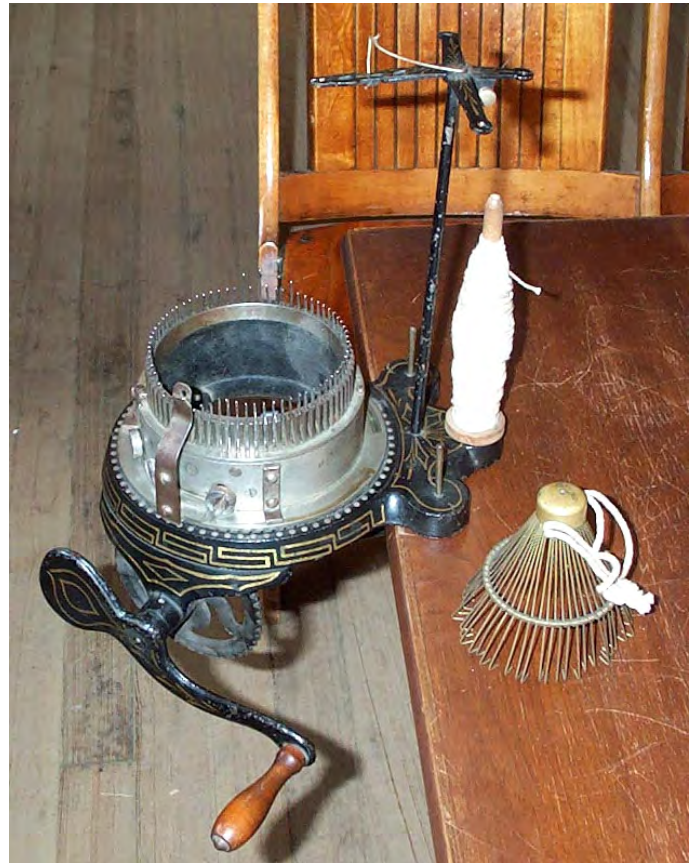
Brattleboro machine full view. Note **Set-up** basket, **Bobbin** and quality of stenciling.

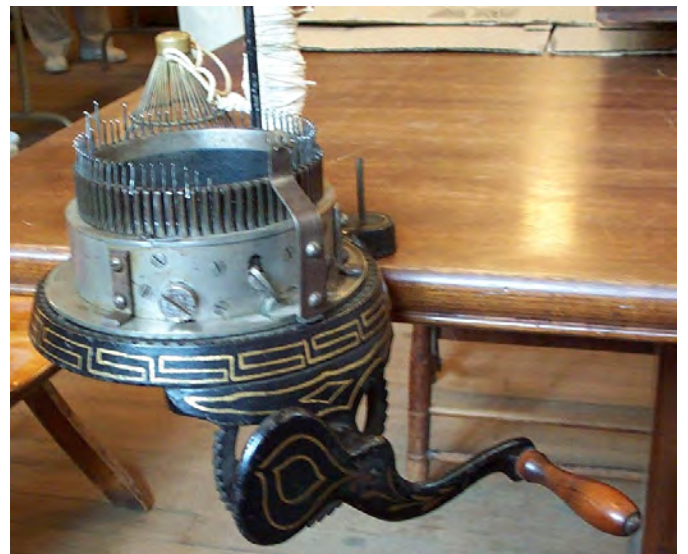
Closer look at carrier and cam adjusting thumb screw. These features differ from the machine in my possession.

The **Crank Wheel** reduction was similar to the Gearhart machines. Three turns of the crank turned the **Cam Ring** two turns.

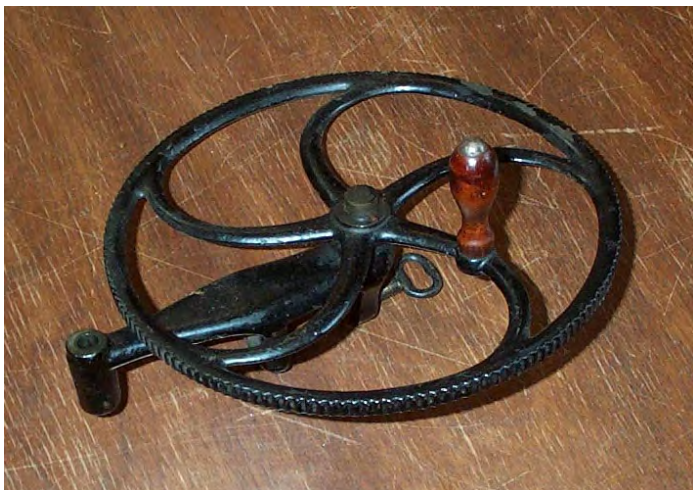
Bickford **Bobbin Winder**. The wheel contacted a rubber roller, not shown.

The **Bobbin Winder** did not use a belt. The knurled wheel contacted a rubber roller to spin the winding shaft. The condition of the **Set-up** basket indicates the machine had very little use, or the owner took good care of the accessories.

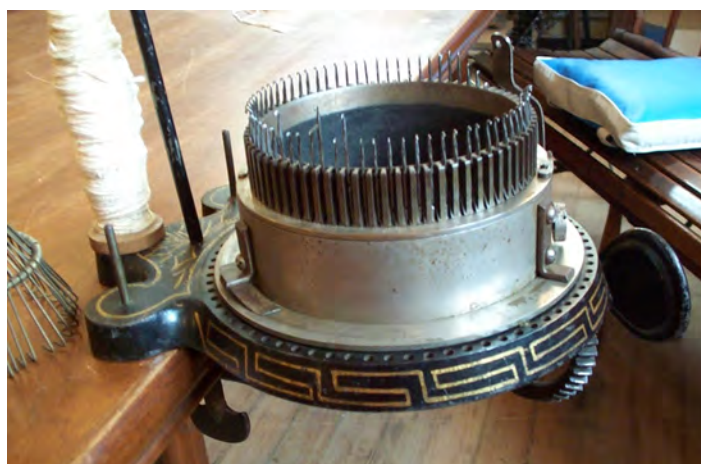
View of left side. Note a series of holes around the base. These hole were for pins that served to stop the carrier and shift the cams into reverse when turning a heel or knitting flat web.

An interesting feature of the Bickford machine is the method of shifting from forward to reverse when turning heels. A pin is inserted in one of the many holes at the base of the machine. The pin stops rotation of the carrier, but allows the cam ring to rotate farther, thus repositioning the cams and carrier to reverse direction.

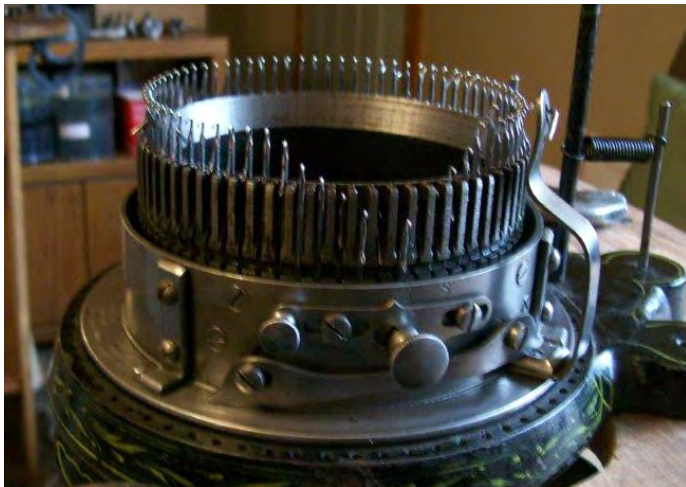
Figure 1. Carrier on the right. Right end of **Automatic Lever** is up.

Figures 1 and 2 show the carrier on the right, then on the left. As the **Yarn-Carrier** and **Slip Ring** are rotated back and forth, the “**Automatic Lever**” rocks like a rocking chair. One end goes down to the **Slip Ring**, and the other end rises to rest on the carrier pad. The **Automatic Lever** is shown again in Figure 3 for better understanding. This movement is required so as to place the carrier on the correct side of the needles in operation. The **Automatic Lever** is connected to a cam inside the **Revolving Cam Ring**. That inside cam determines when needles rise before going under the **Stitch cam**, not shown. Figure 4 shows the **Yarn-Carrier and Sliding Ring** assembly.

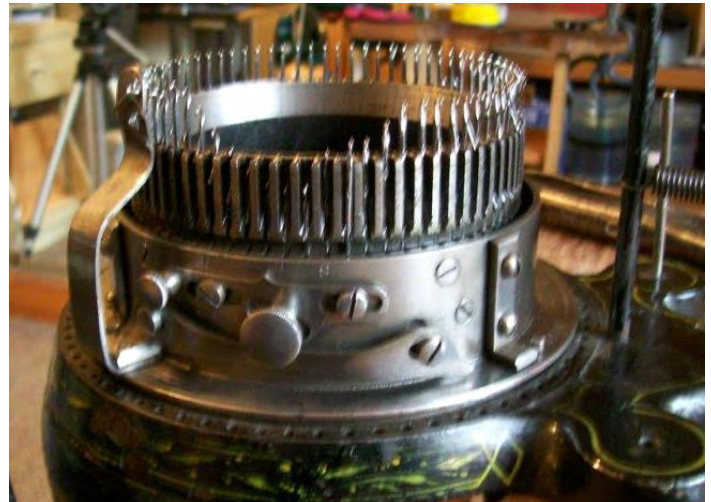
Figure 2. Carrier on the left. Left end of **Automatic Lever** is up.

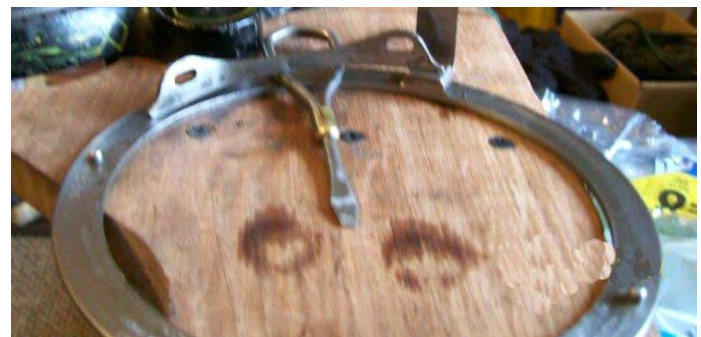
Figure 3. Here the **Automatic Lever** is shown resting on the **Sliding pad** with the right end elevated by the carrier pad.

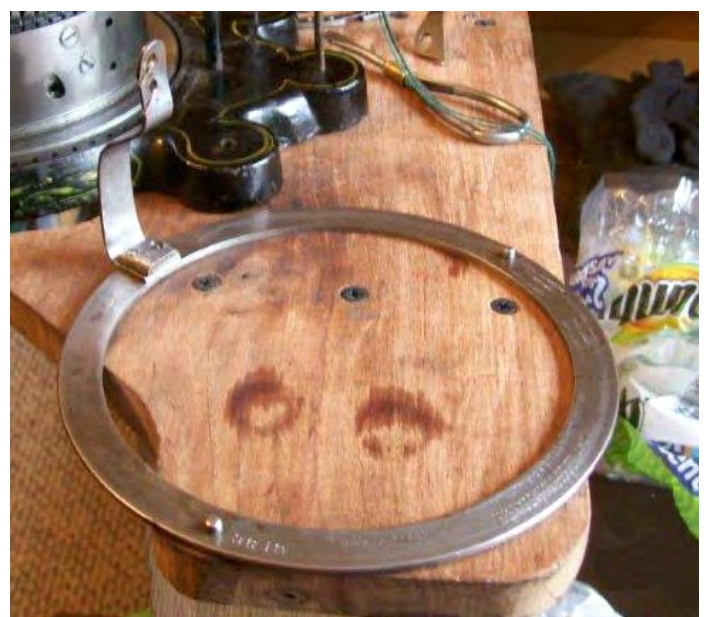
Figure 4. The carrier is shown here mounted on the **Sliding Ring**. Note two short pegs on the **Sliding Ring**. They limit how far the carrier will move when changing direction of rotation.

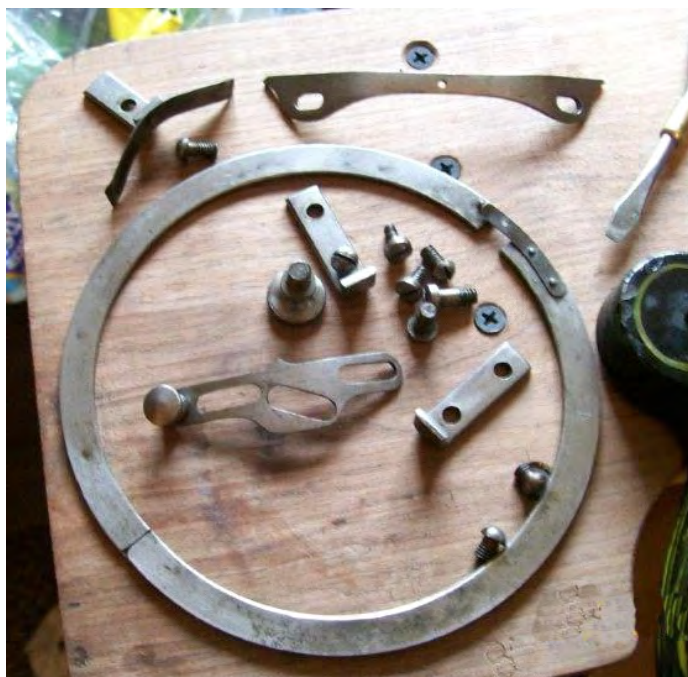
Figure 5. The large ring here is the **Ring Clasp**. It holds needles in the **Needle Cylinder**, and also holds the **Revolving Cam Ring** down against the **Bedplate**.

The **Ring Clasp** must be removed to remove needles. The **Ring Clasp** consists of two semi circular bands hinged on one side with a latch on the other. It removes and installs easily. See Figure 5.

Figures 5 and 6 show the parts removed from the machine. All remaining parts can be removed from the machine as seen in Figure 6, leaving only the **Needle Cylinder** which is secured by two screws.

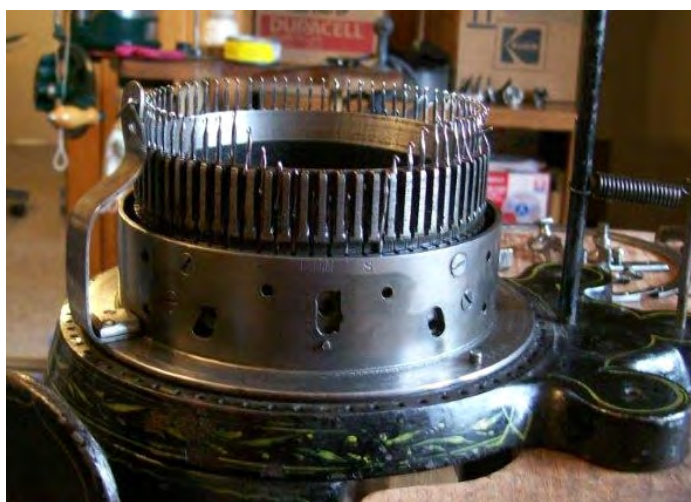
Figure 6. This shows the **Revolving Cam Ring** striped of all screws and external parts. The **Yarn-Carrier and Sliding Ring** assembly can be lifted off the machine in this configuration, without removing the needles or **Revolving Cam Ring**.

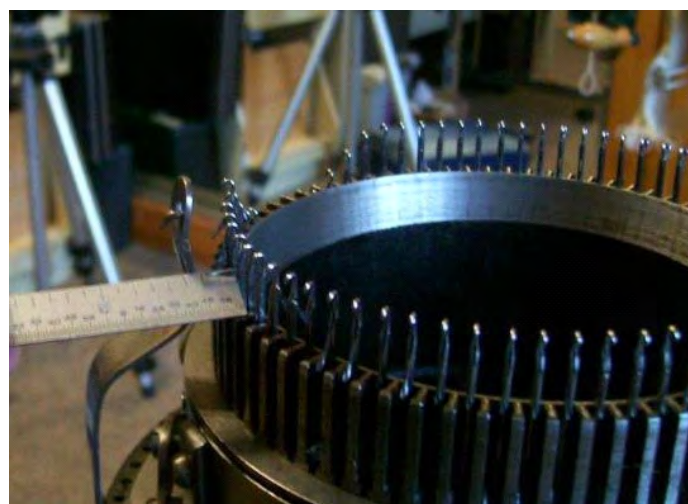
Figure 7. The carrier must be slightly more than a quarter inch from the needles to avoid breaking latches. The delayed timing of the carrier is just right for feeding yarn to the needles.

Figure 7 is all about the space between the needles and carrier. The latches are 1/4 inch long, and if the

carrier is closer than 1/4 inch, they can be broken by the carrier. Other machines require this spacing to be close. The Bickford machine has a built in delayed timing of the carrier that compensates for this wide spacing. When set up as in these images, my Bickford machine knitted tubes with no dropped stitches.

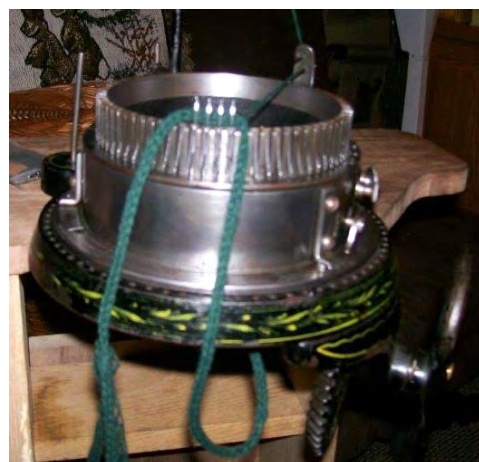
Figure 8. A short length of I-cord was knitted on four needles.

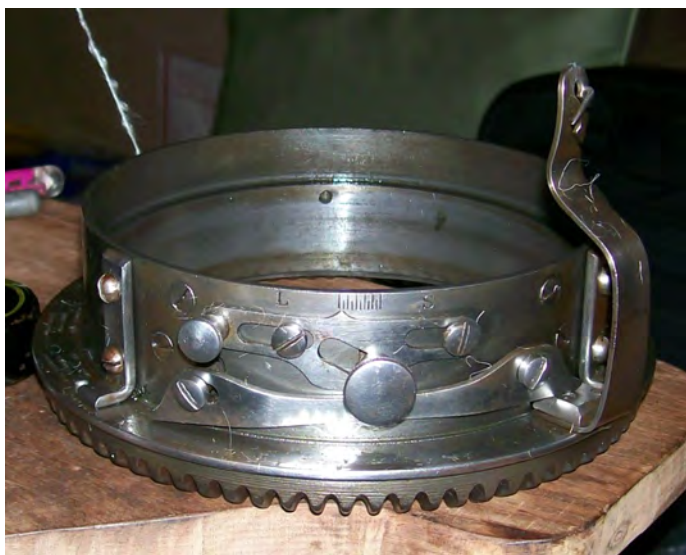
Figure 11. View of cam controls. These controls adjust stitch length and reverse the cams. The **Automatic Lever** was also shown in Figure 3. The right end is resting on the carrier pad.

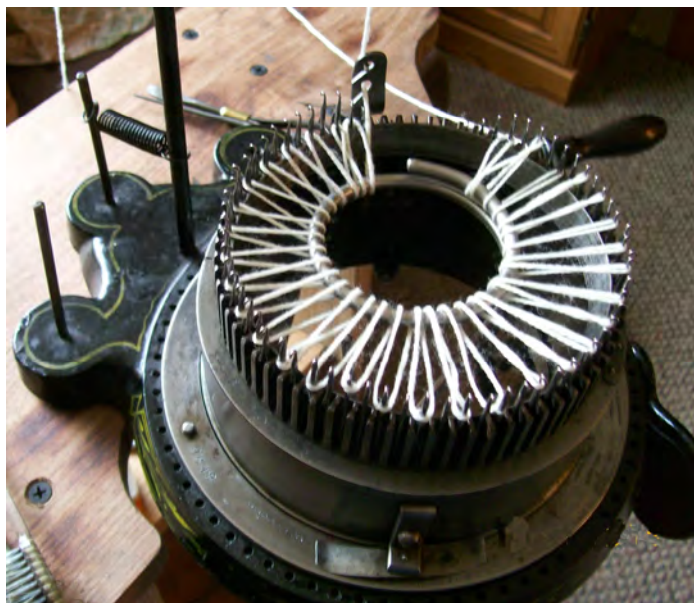
Figure 9. Setting up the Bickford for tubing.

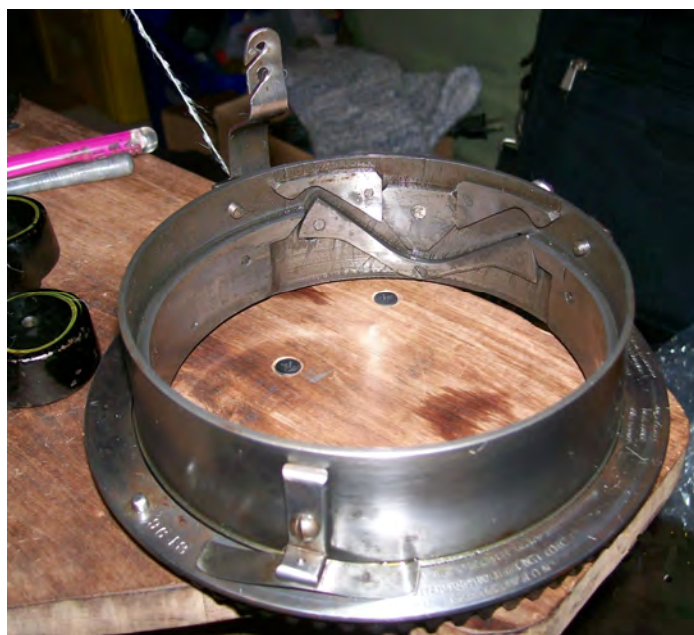
Figure 10. Inside view of cam ring. The serial number on the **Sliding Ring** is 9613.

Figure 10 shows the unique design of the cams. Any modifications to the cams would spoil the originality of the machine.

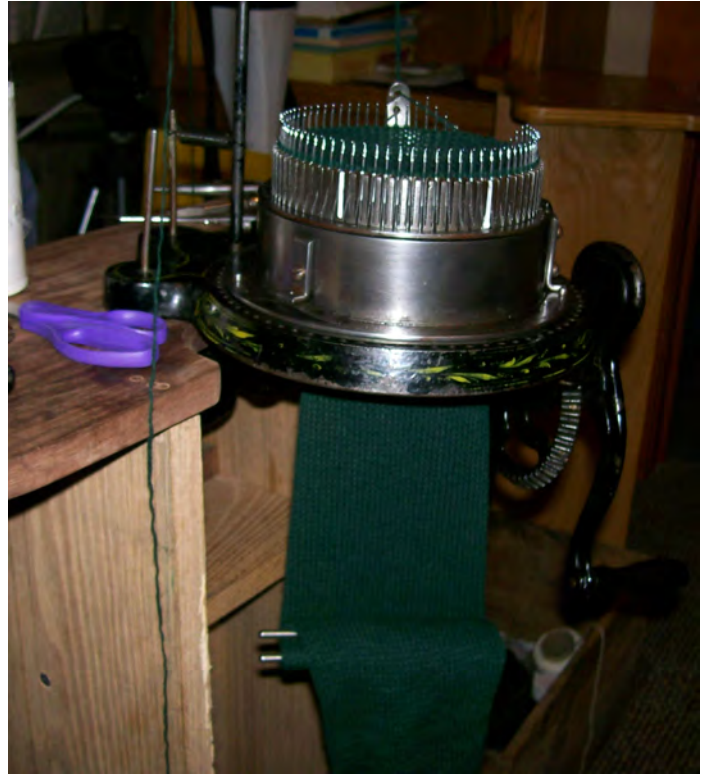
Figure 12. Sixty inches of yarn tubing was done with no dropped stitches.

After knitting some I-cord on 4 needles, the machine was set up to knit tubing. Sixty inches of tubing was knitted with out a single dropped stitch. That will be finished as a scarf.
