The Bickford Family Knitting Machine

By Fred Hauck

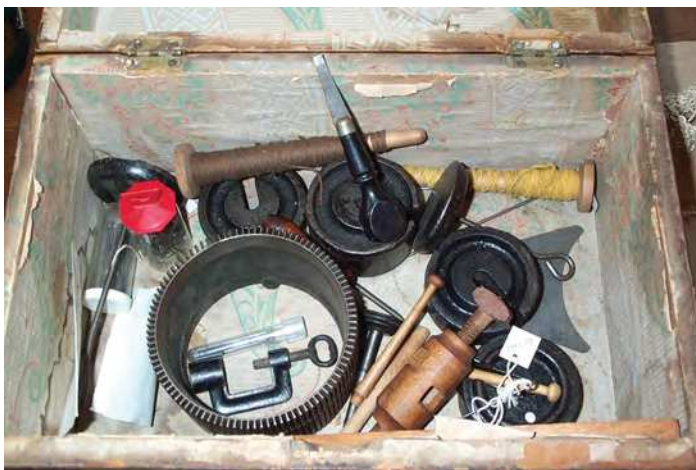
This box is not likely to be an original container. It would not accommodate the machine and all accessories. Note screw driver, cylinder, weights, bobbins and pack of needles (red cap) The clamp inside the cylinder is a swift mounting clamp.

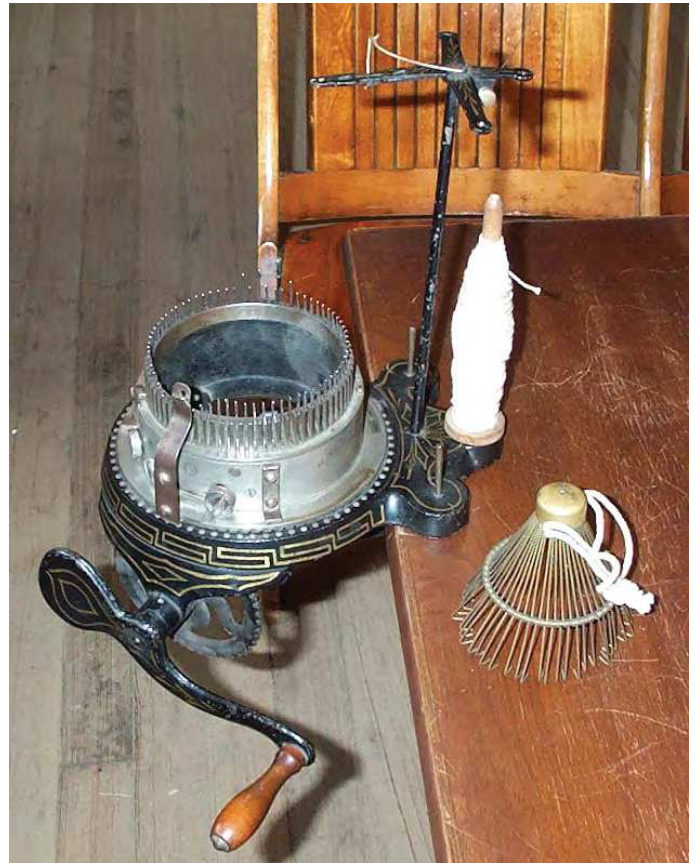
Brattleboro machine full view. Note **Set-up** basket, **Bobbin** and quality of stenciling.

The **Bobbin Winder** did not use a belt. The knurled wheel contacted a rubber roller to spin the winding shaft. The condition of the **Set-up** basket indicates the machine had very little use, or the owner took good care of the accessories.

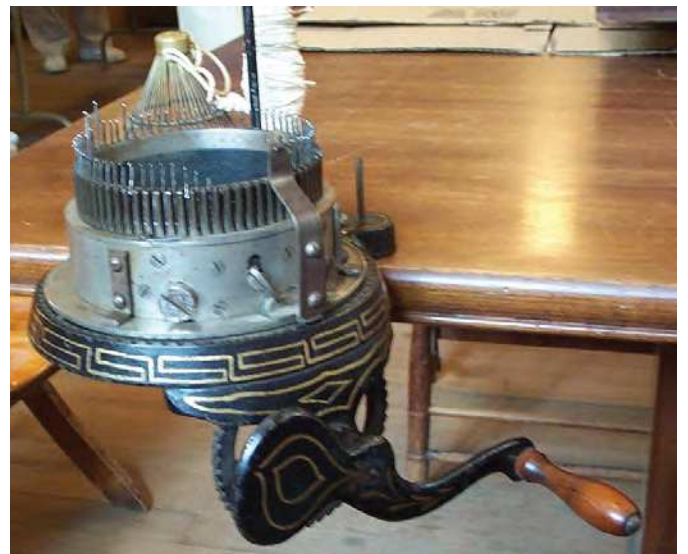
Closer look at carrier and cam adjusting thumb screw. These features differ from the machine in my possession.

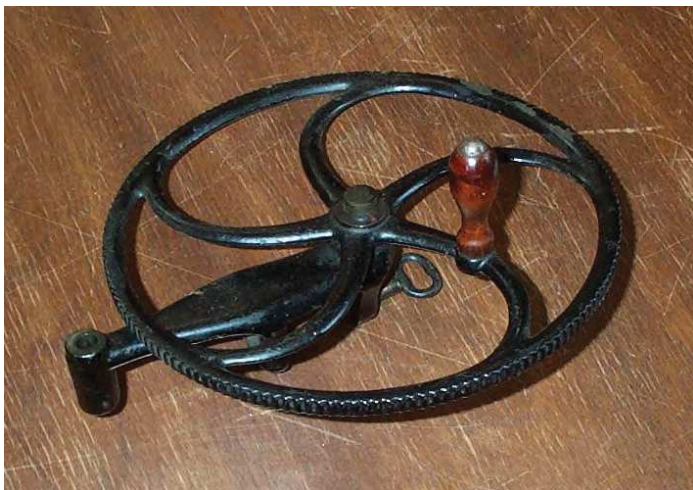
Bickford **Bobbin Winder**. The wheel contacted a rubber roller, not shown.

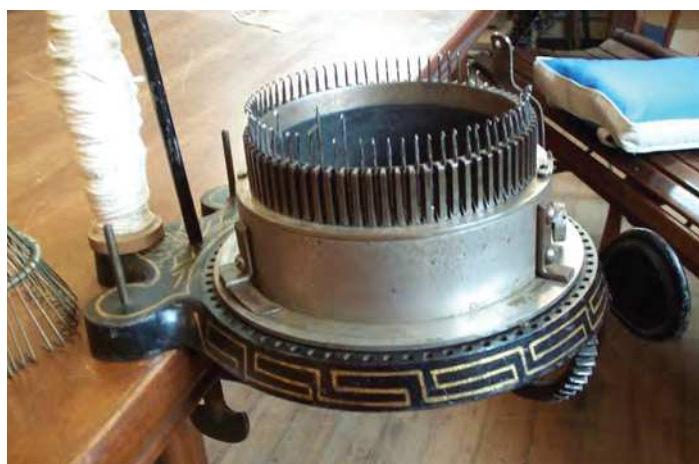
View of left side. Note a series of holes around the base. These hole were for pins that served to stop the carrier and shift the cams into reverse when turning a heel or knitting flat web.

An interesting feature of the Bickford machine is the method of shifting from forward to reverse when turning heels. A pin is inserted in one of the many holes at the base of the machine. The pin stops rotation of the carrier, but allows the cam ring to rotate farther, thus repositioning the cams and carrier to reverse direction.

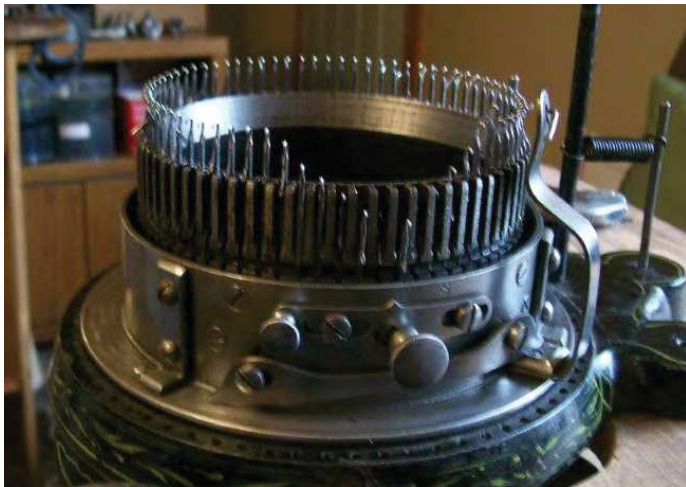
Figure 1. Carrier on the right. Right end of **Automatic Lever** is up.

Figures 1 and 2 show the carrier on the right, then on the left. As the **Yarn-Carrier** and **Slip Ring** are rotated back and forth, the “**Automatic Lever**” rocks like a rocking chair. One end goes down to the **Slip Ring**, and the other end rises to rest on the carrier pad. The **Automatic Lever** is shown again in Figure 3 for better understanding. This movement is required so as to place the carrier on the correct side of the needles in operation. The **Automatic Lever** is connected to a cam inside the **Revolving Cam Ring**. That inside cam determines when needles rise before going under the **Stitch cam**, not shown. Figure 4 shows the **Yarn-Carrier** and **Sliding Ring** assembly.

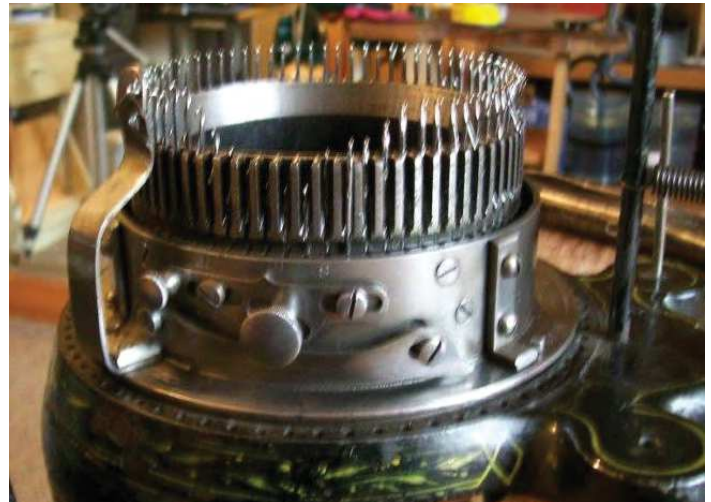
Figure 2. Carrier on the left. Left end of **Automatic Lever** is up.

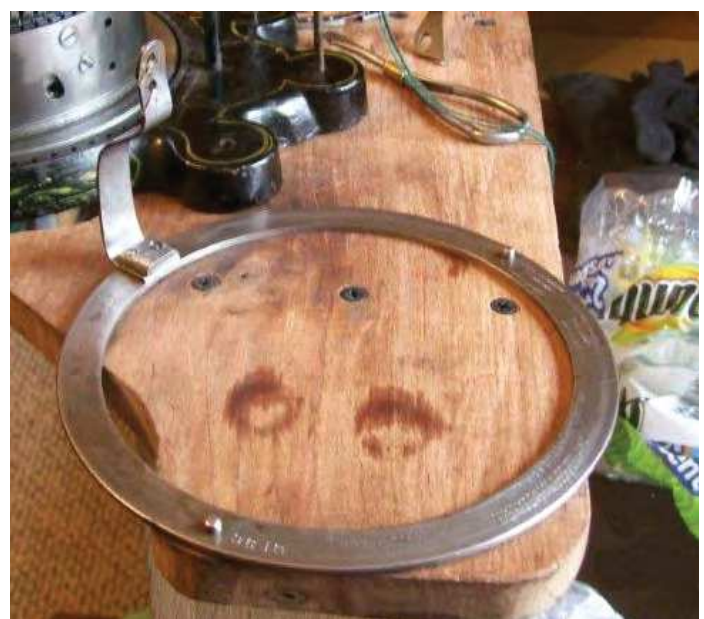
Figure 4. The carrier is shown here mounted on the **Sliding Ring**. Note two short pegs on the **Sliding Ring**. They limit how far the carrier will move when changing direction of rotation.

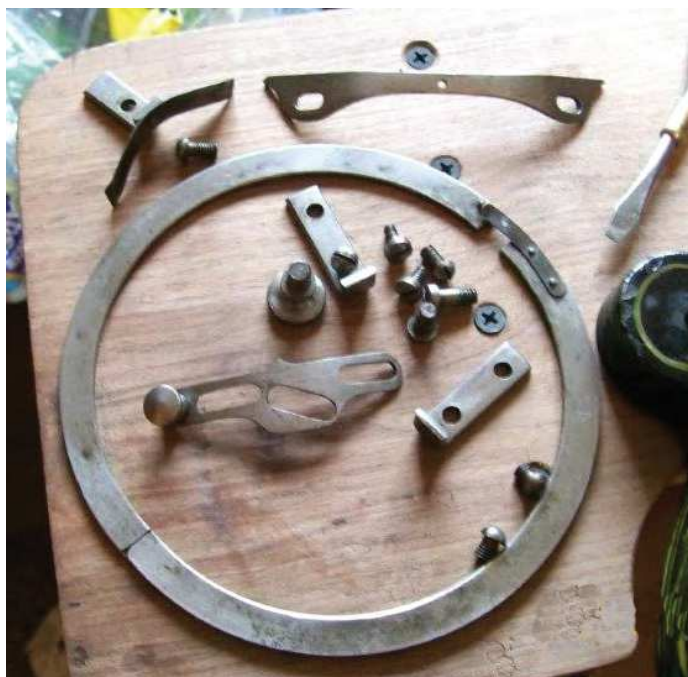
Figure 5. The large ring here is the **Ring Clasp**. It holds needles in the **Needle Cylinder**, and also holds the **Revolving Cam Ring** down against the **Bedplate**.

The **Ring Clasp** must be removed to remove needles. The **Ring Clasp** consists of two semi circular bands hinged on one side with a latch on the other. It removes and installs easily. See Figure 5.

Figures 5 and 6 show the parts removed from the machine. All remaining parts can be removed from the machine as seen in Figure 6, leaving only the **Needle Cylinder** which is secured by two screws.

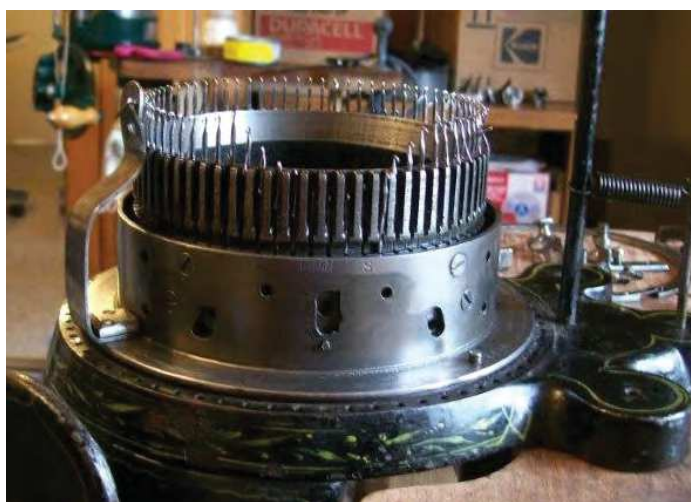
Figure 6. This shows the **Revolving Cam Ring** striped of all screws and external parts. The **Yarn-Carrier and Sliding Ring** assembly can be lifted off the machine in this configuration, without removing the needles or **Revolving Cam Ring**.

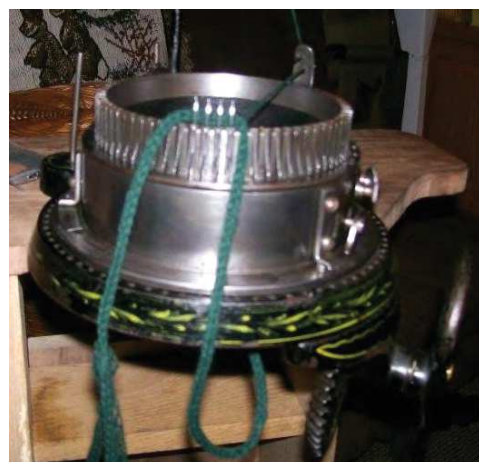
Figure 8. A short length of I-cord was knitted on four needles.

After knitting some I-cord on 4 needles, the machine was set up to knit tubing. Sixty inches of tubing was knitted with out a single dropped stitch. That will be finished as a scarf.

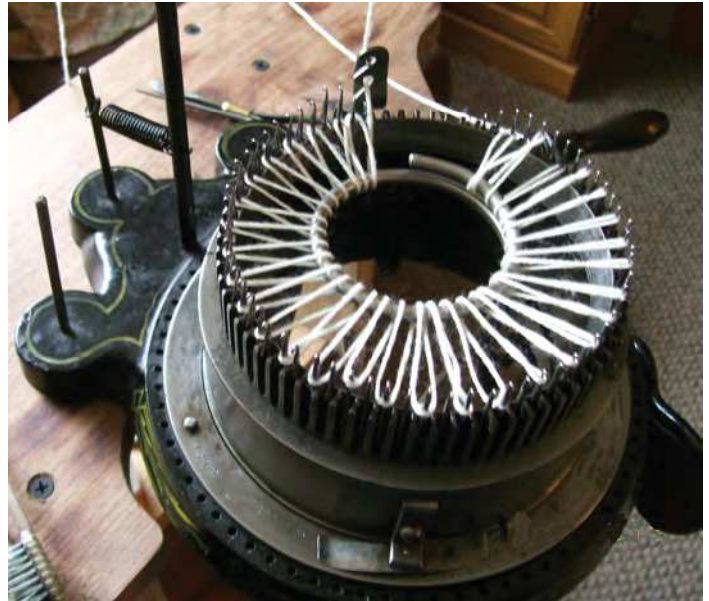
Figure 9. Setting up the Bickford for tubing.

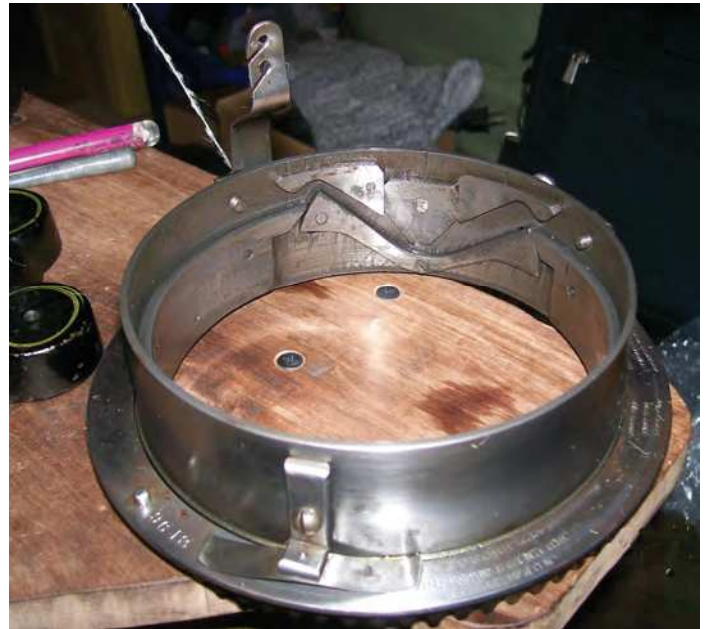
Figure 10. Inside view of cam ring. The serial number on the **Sliding Ring** is 9613.

Figure 10 shows the unique design of the cams. Any modifications to the cams would spoil the originality of the machine.

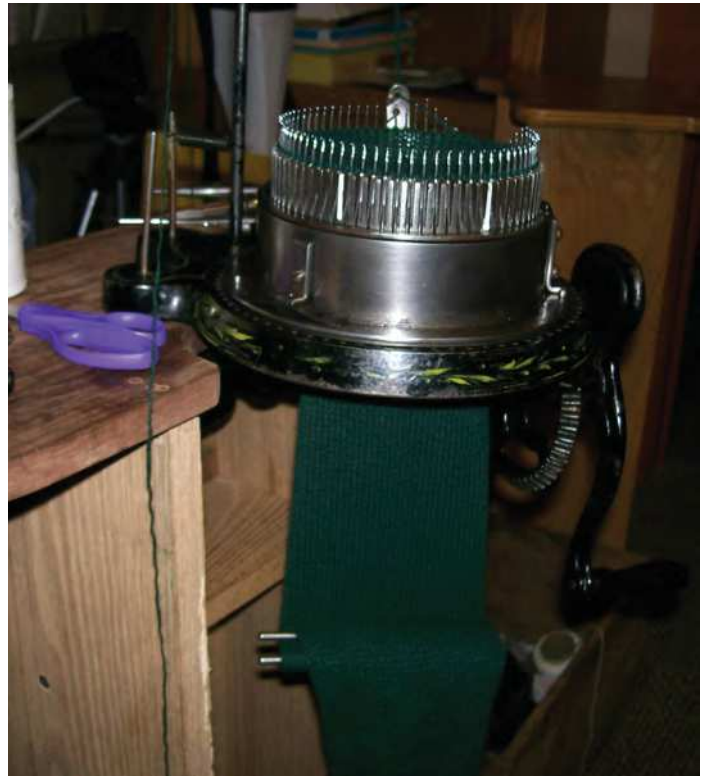
Figure 12. Sixty inches of yarn tubing was done with no dropped stitches.
