The Bickford Family Knitting Machine

By Fred Hauck

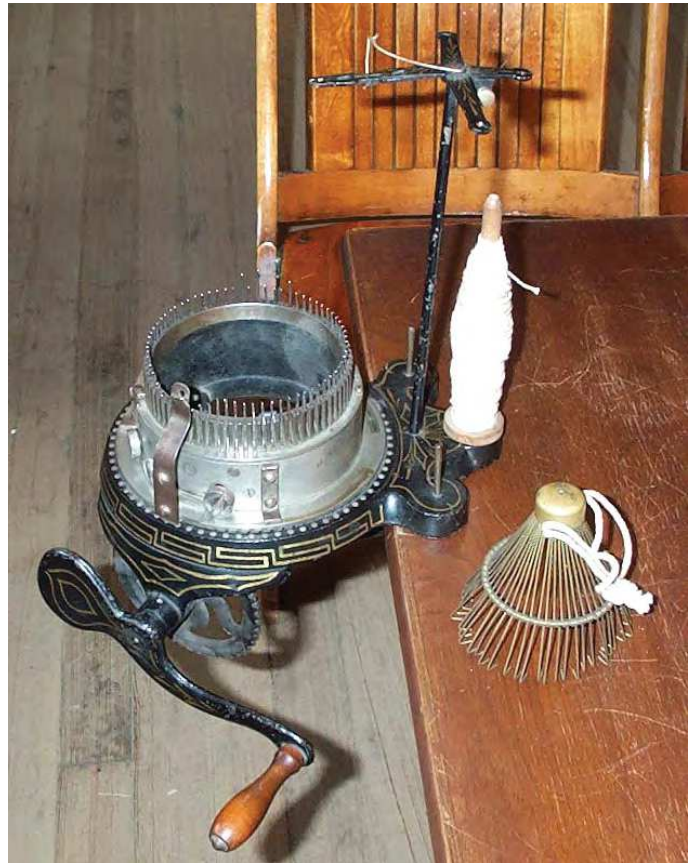
Brattleboro machine full view. Note **Set-up** basket, **Bobbin** and quality of stenciling.

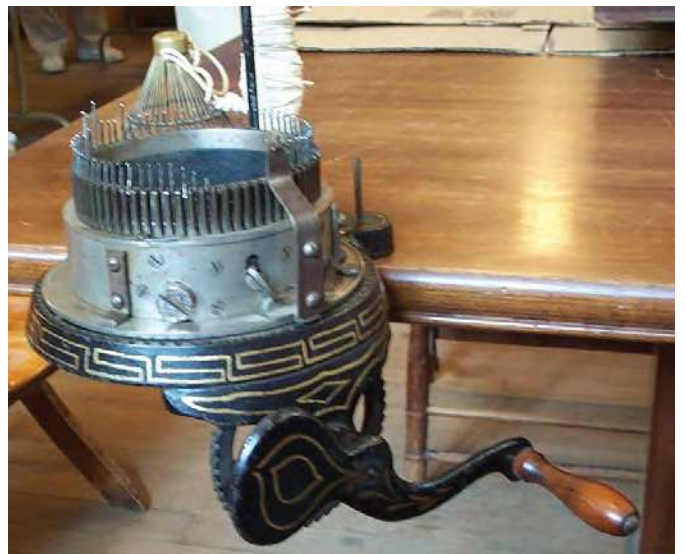
Closer look at carrier and cam adjusting thumb screw. These features differ from the machine in my possession.

The **Bobbin Winder** did not use a belt. The knurled wheel contacted a rubber roller to spin the winding shaft. The condition of the **Set-up** basket indicates the machine had very little use, or the owner took good care of the accessories.

The **Crank Wheel** reduction was similar to the Gearhart machines. Three turns of the crank turned the **Cam Ring** two turns.

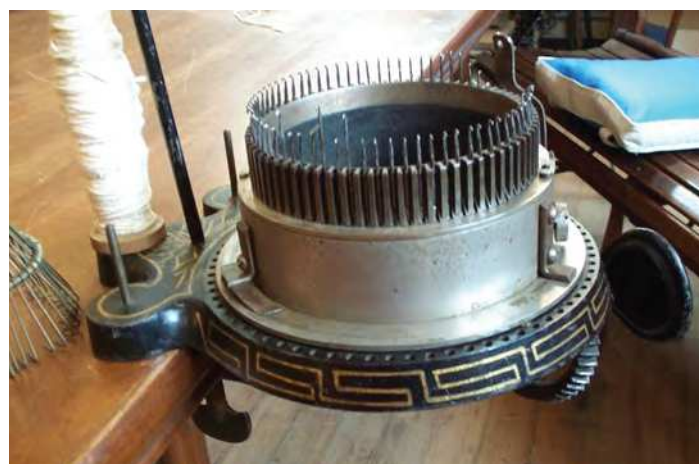
View of left side. Note a series of holes around the base. These hole were for pins that served to stop the carrier and shift the cams into reverse when turning a heel or knitting flat web.

An interesting feature of the Bickford machine is the method of shifting from forward to reverse when turning heels. A pin is inserted in one of the many holes at the base of the machine, The pin stops rotation of the carrier, but allows the cam ring to rotate farther, thus repositioning the cams and carrier to reverse direction.

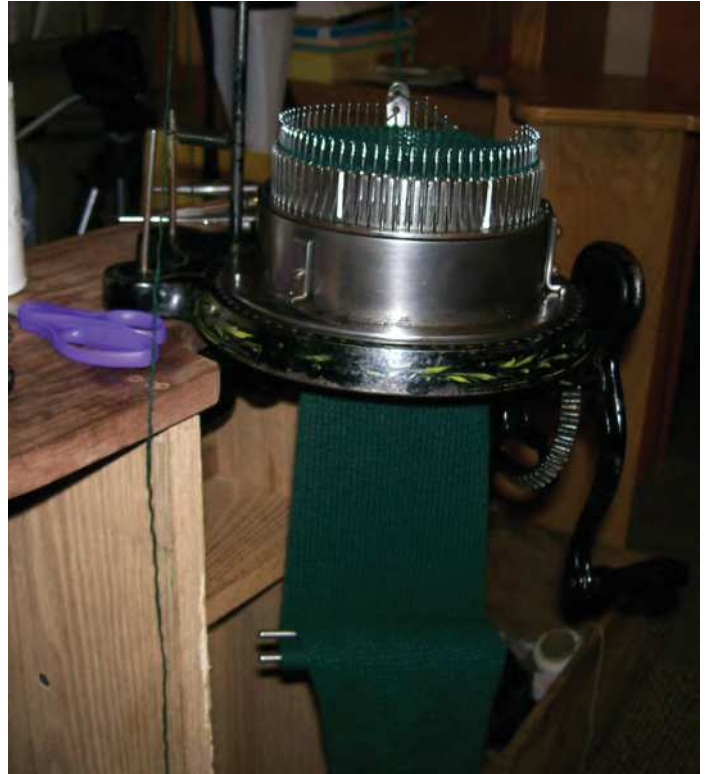
Figure 12. Sixty inches of yarn tubing was done with no dropped stitches.

After knitting some I-cord on 4 needles, the machine was set up to knit tubing. Sixty inches of tubing was knitted with out a single dropped stitch. That will be finished as a scarf.
